MOT failures

The main defect items presenters miss, which DVSA don't!
(And what you can do about this)

Guidance document

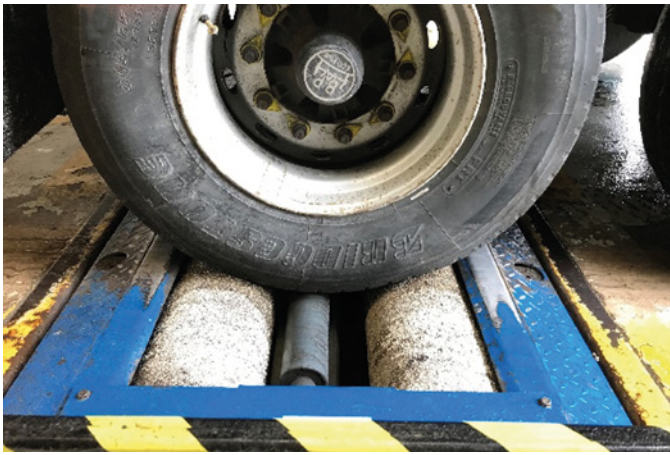
Fig 1: Roller brake tester

For 'service brake performance', the main defect for trailers (76%) is failing to achieve the overall percentage brake performance.

The main defect for vehicles (53%) is significant brake imbalance (failing to achieve 50% of the brake effort of the other wheel across an axle). DVSA categorise this as a 'Dangerous' defect and could result in prohibition action and possible follow-up action.

The other main 'service brake performance' defect is for major imbalance (failing to achieve 70% of the brake effort of the other wheel across an axle). For vehicles this accounts for 28% of all 'service brake performance' defects, and for trailers it's 15%.

We recommend a full roller brake performance test be undertaken on an approved and calibrated machine as part of your preparation. As a minimum this should be undertaken in the same condition (laden where necessary) as that to which it will be MOT tested. The operation should be undertaken in the same manner as that of the MOT (vehicle aligned, full air pressure and operation performed slowly), with the results being fully analysed.

Applying the brakes quickly, to obtain a lock-out, offers false assurance that the brake is operating satisfactorily. In fact, that action doesn't allow the brake effort to build between the tyre and brake test roller, resulting in failure to obtain the highest possible brake effort reading, and is therefore not representative of the brake's maximum performance during MOT test conditions.

Particular interest should be given to low figure lock-outs, or high percentage imbalances across an axle, as this may indicate a potential brake problem. Logistics UK's Brake Test guidance document provides more information on how to read and understand brake test reports – go to:

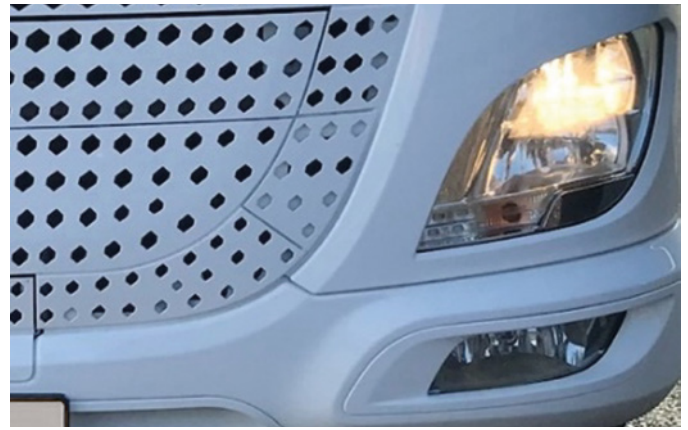
Fig 2: Headlamp

86% of all failures for headlamp aim are due to a headlamp beam being too high or low.

Always check the vehicle's headlamps in the same condition as it will be presented for MOT. For example, if it is to be loaded for test, check it in its loaded state. Ensure the suspension has settled – this may require some dynamic braking events. Ensure staff are competent with operating the testing equipment and are able

to interpret the image displayed to establish whether the beam passes or fails.

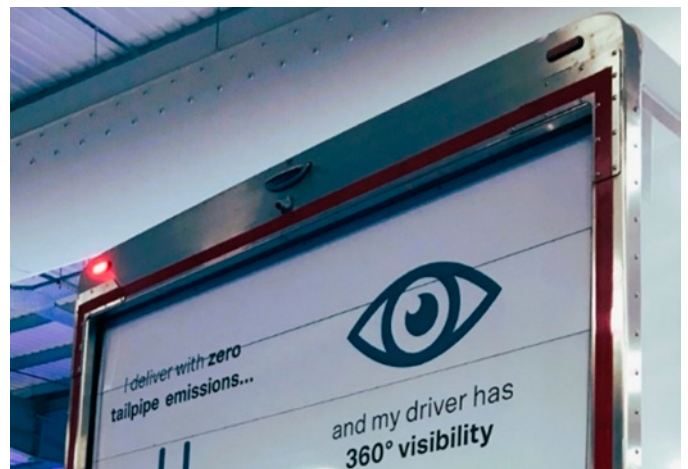
Fig 3: Outline marker lamp

79% of all vehicle lamp failures, and 83% of all trailer lamp failures are due to an obligatory lamp missing or inoperative.

Further analysis by Logistics UK identified that most lamps that tend to be overlooked are outline marker lamps – those that are fitted upwards of the eye line. Additionally, preparers may not be clear of the dates of obligatory lamps, so fail to check their fitment.

End outline marker lamps: Are required to be fitted to:

- Vehicles first used from 1 April 1991.
- Trailers manufactured from 1 October 1990.

and which in both cases are more than 2.1m wide.

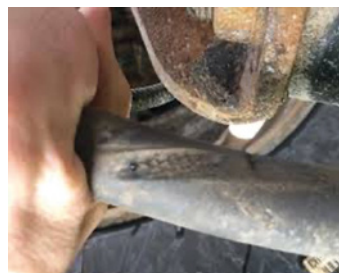
Fig 5: Damaged brake hose

Damaged or deformed flexible hoses, or excessively corroded brake pipes, account for 16% of all vehicles, and 12% of all trailer, braking system and component defects. With 11% of vehicles and 19% of trailer braking system defects being for air leakage at those components.

Air/Fluid leaks: Always check the whole braking system and hoses under full pressure, using an assistant where necessary. In day-to-day use drivers rarely use their brakes under full pressure. So unless this is carried out before the MOT, then it is likely that any weakness in the system will only be found at MOT – where DVSA place the system under full pressure.

Condition of components: Moving components should be assessed in operation (repeating operation as necessary) to ensure they are both secure and operating correctly. Components need to be reasonably clean, so a meaningful evaluation can be made of their condition. Never take anything for granted and where replacement components are found, check that they have been fitted correctly and completely – missing split pins and/or loose locking/retaining nuts are not uncommon.

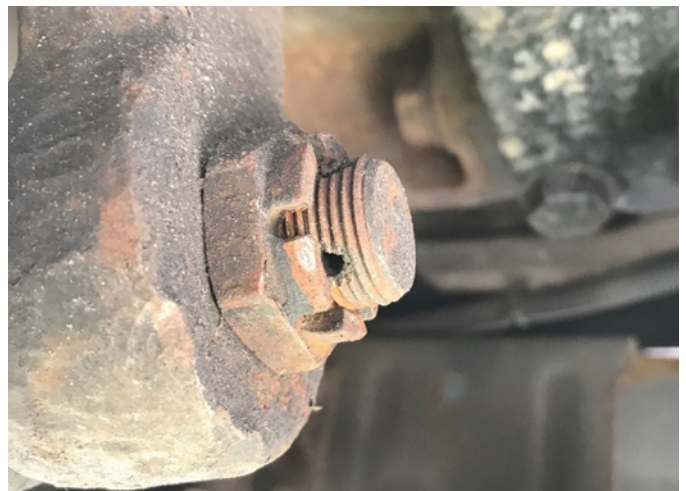
Fig 6: Missing split pin

29% of all these steering defects are related to ball joint covers missing, insecure, excessively damaged or severely deteriorated. 11% are for steering components, wheels or tyres fouling any part of the vehicle and 8% are for a retaining or locking device ineffective, not fitted, or insecure.

Locking devices: Check for the presence of these and their security. Where replacement components are found, check that they have been fitted correctly and completely.

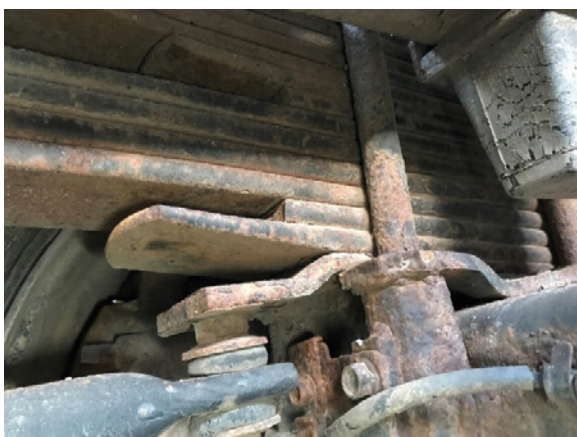
Fig 7: Broken spring

- 13% for deteriorated rubber or bonded bushes.
- 13% for insecure suspension components.
- 9% for fractured leaf springs.
- 8% for damaged, worn or distorted components.
- 8% for air leaks.

Condition of components: As with the previous guidance, components need to be reasonably clean for a meaningful evaluation to be made of their condition.

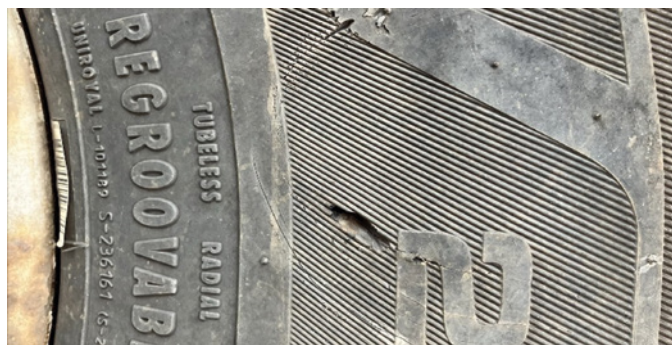
Fig 8: Tyre wall damage

36% of tyre MOT failures on vehicles (40% for trailers) are due to having exposed ply or cords. A further 31% of tyre MOT failures on vehicles (45% for trailers) are due to cuts in a tyre deep enough to reach the ply or cords.

Condition of tyres: You need to check the whole 360° of a tyre for cuts and/or exposed ply or cords – which may necessitate rotating the tyres or moving the vehicle forward/backwards. Both the tread area and both side walls of each tyre should be examined and where a cut (exceeding 25mm or 10% of the section width) is seen, then further investigation should be made to ensure that the cut does not reach the ply or cords.

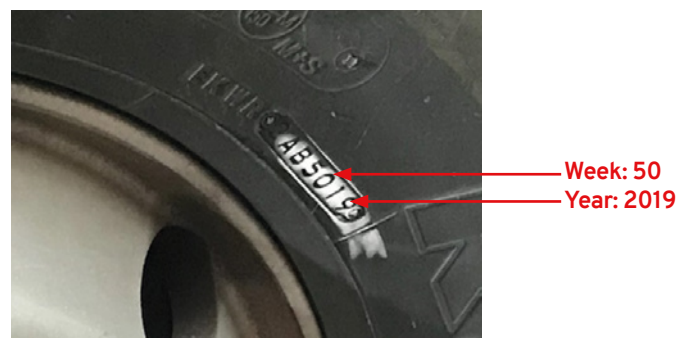
Fig 9: Tyre date markings

Surprisingly, 14% of tyre MOT failures on vehicles were due to the tyre fitted on a front steered axle being over 10 years old.

Age of tyres: You should try to identify the age marking of all tyres and note this on records. No tyre over the age of 10 years can be fitted to the front steered axle of a HGV. See fig 9.

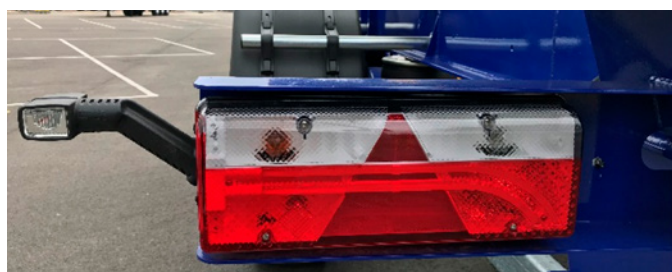
Fig 10: Rear reflector

88% of all failure items in this category are for reflectors either missing, incorrectly positioned, or showing the wrong colour.

Rear Reflectors: The maximum height from the ground is 900mm, though there are some exceptions:

- If 900mm is impractical it can be 1,500mm.
- For vehicles used before 1 April 1986 and trailers manufactured before 1 October 1985 the maximum height is 1,525mm.

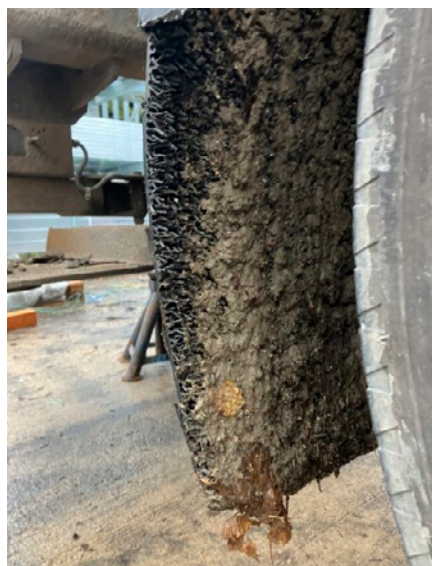
Fig 11: Spray suppression

47% of failures in this category are due to the spray suppression being clogged with mud or debris. A further 23% due to the spray suppression dimensional requirements not being complied with.

Cleanliness: For spray suppression to perform adequately it must be maintained in a reasonably clean state. Ensure that the cleaning of a vehicle for inspection includes the spray suppression. To do this effectively, this will usually require the use of a high-pressure jet washer.

Dimensional requirements: Although there are particular dimensional requirements for different types of spray suppression (see the HGV Inspection Manual for full details), there are a few general rules:

- **Height of the flap from the road** – 200mm, this can be increased to 300mm in some circumstances.
- **Width of coverage** – for vehicles/trailers first used from 1 April 2000 it must cover the whole width of the tyre/s. For vehicles/trailers first used before 1 April 2000, it only needs to cover the tyre/s tread breadth.
- **Fitment between wheels** – for multi-axle arrangements, if the distance between the tyres is greater than 250mm (this can be up to 290mm in some circumstances), then additional spray suppression flaps will need to be fitted between those tyres.
