## MOT failures

The main defect items presenters miss, which DVSA don't!  
(And what you can do about this)

### Guidance document

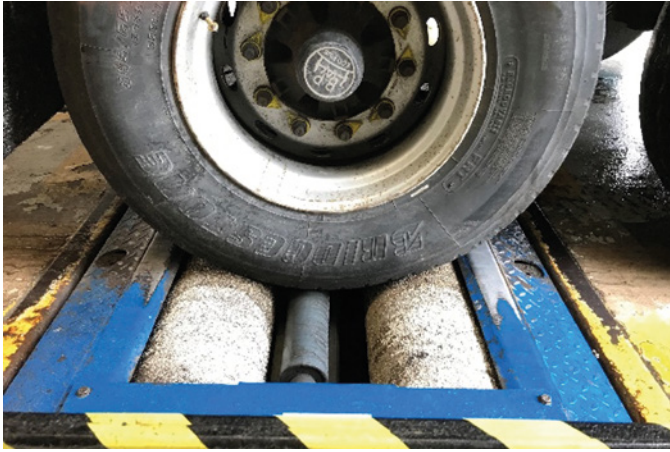
Fig 1: Roller brake tester

For 'service brake performance', the main defect for trailers (76%) is failing to achieve the overall percentage brake performance.

The main defect for vehicles (53%) is significant brake imbalance (failing to achieve 50% of the brake effort of the other wheel across an axle). DVSA categorise this as a 'Dangerous' defect and could result in prohibition action and possible follow-up action.

The other main 'service brake performance' defect is for major imbalance (failing to achieve 70% of the brake effort of the other wheel across an axle). For vehicles this accounts for 28% of all 'service brake performance' defects, and for trailers it's 15%.

We recommend a full roller brake performance test be undertaken on an approved and calibrated machine as part of your preparation. As a minimum this should be undertaken in the same condition (laden where necessary) as that to which it will be MOT tested. The operation should be undertaken in the same manner as that of the MOT (vehicle aligned, full air pressure and operation performed slowly), with the results being fully analysed.

Applying the brakes quickly, to obtain a lock-out, offers false assurance that the brake is operating satisfactorily. In fact, that action doesn't allow the brake effort to build between the tyre and brake test roller, resulting in failure to obtain the highest possible brake effort reading, and is therefore not representative of the brake's maximum performance during MOT test conditions.

Particular interest should be given to low figure lock-outs, or high percentage imbalances across an axle, as this may indicate a potential brake problem. Logistics UK's Brake Test guidance document provides more information on how to read and understand brake test reports – go to:

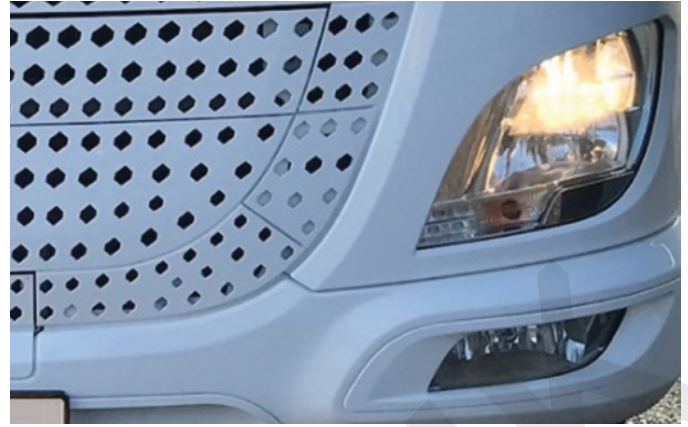
Fig 2: Headlamp

86% of all failures for headlamp aim are due to a headlamp beam being too high or low.

Always check the vehicle's headlamps in the same condition as it will be presented for MOT. For example, if it is to be loaded for test, check it in its loaded state. Ensure the suspension has settled – this may require some dynamic braking events. Ensure staff are competent with operating the testing equipment and are able

to interpret the image displayed to establish whether the beam passes or fails.

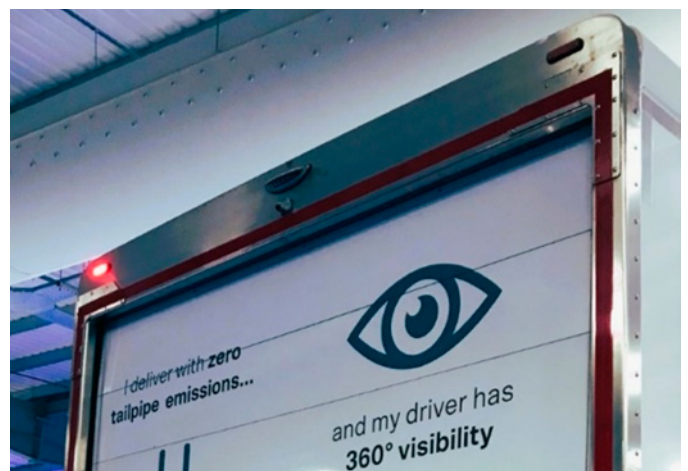
Fig 3: Outline marker lamp

Further analysis by Logistics UK identified that most lamps that tend to be overlooked are outline marker lamps – those that are fitted upwards of the eye line. Additionally, preparers may not be clear of the dates of obligatory lamps, so fail to check their fitment.

**End outline marker lamps:** Are required to be fitted to:

- Vehicles first used from 1 April 1991.
- Trailers manufactured from 1 October 1990.

and which in both cases are more than 2.1m wide.

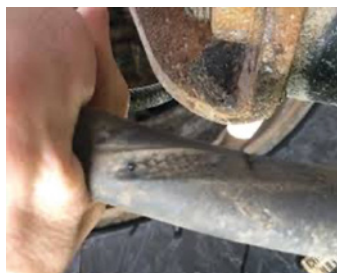
Fig 5: Damaged brake hose

Damaged or deformed flexible hoses, or excessively corroded brake pipes, account for 16% of all vehicles, and 12% of all trailer, braking system and component defects. With 11% of vehicles and 19% of trailer braking system defects being for air leakage at those components.

**Air/Fluid leaks:** Always check the whole braking system and hoses under full pressure, using an assistant where necessary. In day-to-day use drivers rarely use their brakes under full pressure. So unless this is carried out before the MOT, then it is likely that any weakness in the system will only be found at MOT – where DVSA place the system under full pressure.

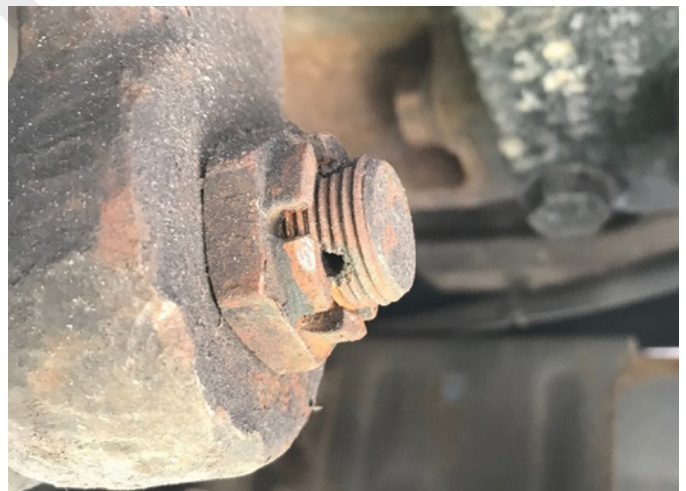
Fig 6: Missing split pin

29% of all these steering defects are related to ball joint covers missing, insecure, excessively damaged or severely deteriorated. 11% are for steering components, wheels or tyres fouling any part of the vehicle and 8% are for a retaining or locking device ineffective, not fitted, or insecure.

**Locking devices:** Check for the presence of these and their security. Where replacement components are found, check that they have been fitted correctly and completely.

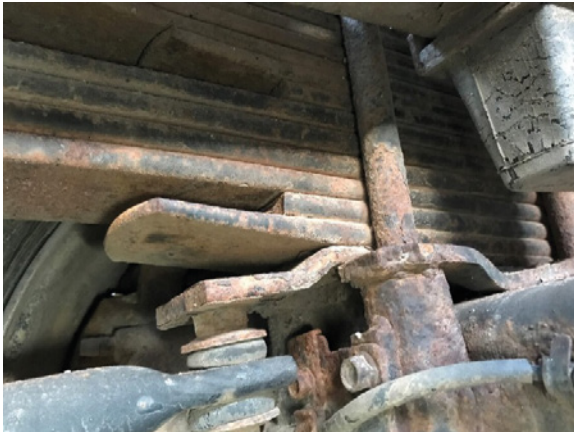
Fig 7: Broken spring

- 13% for deteriorated rubber or bonded bushes.
- 13% for insecure suspension components.
- 9% for fractured leaf springs.
- 8% for damaged, worn or distorted components.
- 8% for air leaks.

**Condition of components:** As with the previous guidance, components need to be reasonably clean for a meaningful evaluation to be made of their condition.

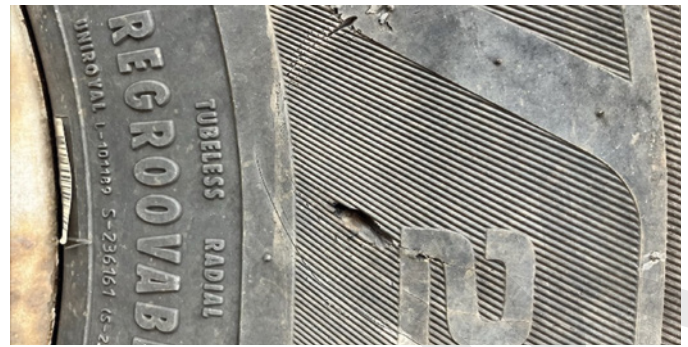
Fig 8: Tyre wall damage

36% of tyre MOT failures on vehicles (40% for trailers) are due to having exposed ply or cords. A further 31% of tyre MOT failures on vehicles (45% for trailers) are due to cuts in a tyre deep enough to reach the ply or cords.

**Condition of tyres:** You need to check the whole 360° of a tyre for cuts and/or exposed ply or cords – which may necessitate rotating the tyres or moving the vehicle forward/backwards. Both the tread area and both side walls of each tyre should be examined and where a cut (exceeding 25mm or 10% of the section width) is seen, then further investigation should be made to ensure that the cut does not reach the ply or cords.

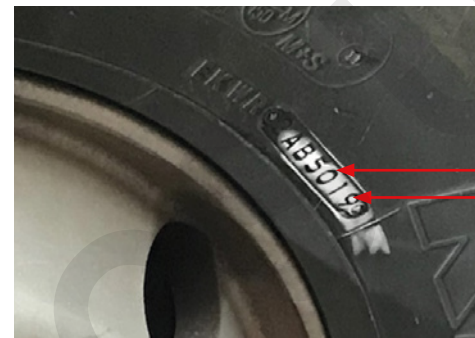
Fig 9: Tyre date markings

**Age of tyres:** You should try to identify the age marking of all tyres and note this on records. No tyre over the age of 10 years can be fitted to the front steered axle of a HGV. See fig 9.

Surprisingly, 14% of tyre MOT failures on vehicles were due to the tyre fitted on a front steered axle being over 10 years old.

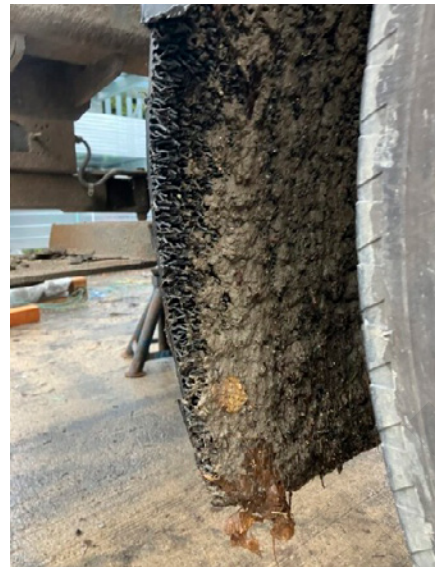
Fig 11: Spray suppression

47% of failures in this category are due to the spray suppression being clogged with mud or debris. A further 23% due to the spray suppression dimensional requirements not being complied with.

**Cleanliness:** For spray suppression to perform adequately it must be maintained in a reasonably clean state. Ensure that the cleaning of a vehicle for inspection includes the spray suppression. To do this effectively, this will usually require the use of a high-pressure jet washer.

**Dimensional requirements:** Although there are particular dimensional requirements for different types of spray suppression (see the HGV Inspection Manual for full details), there are a few general rules:

- **Height of the flap from the road** – 200mm, this can be increased to 300mm in some circumstances.
- **Width of coverage** – for vehicles/trailers first used from 1 April 2000 it must cover the whole width of the tyre/s. For vehicles/trailers first used before 1 April 2000, it only needs to cover the tyre/s tread breadth.
- **Fitment between wheels** – for multi-axle arrangements, if the distance between the tyres is greater than 250mm (this can be up to 290mm in some circumstances), then additional spray suppression flaps will need to be fitted between those tyres.
